Twenty Years of Restoration at Kelso Quarry Park

Restoring Resilience: Big Impacts across Small Spaces
October 26th, 2016

Nigel Finney
Watershed Restoration Planner
Conservation Halton

Quarry Lake
Enhancement Project
2015/16

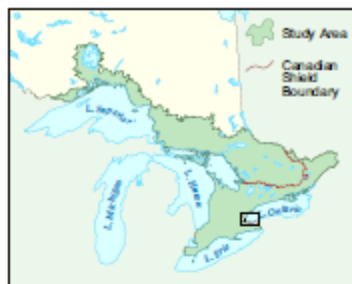
GRIMSBY ECODISTRICT 7E-3

Great Lakes Conservation Blueprint for Biodiversity

Terrestrial Conservation Blueprint

- Parks and Protected Areas
- Additional Designated Natural Heritage Lands
- Other Priority Stewardship Lands

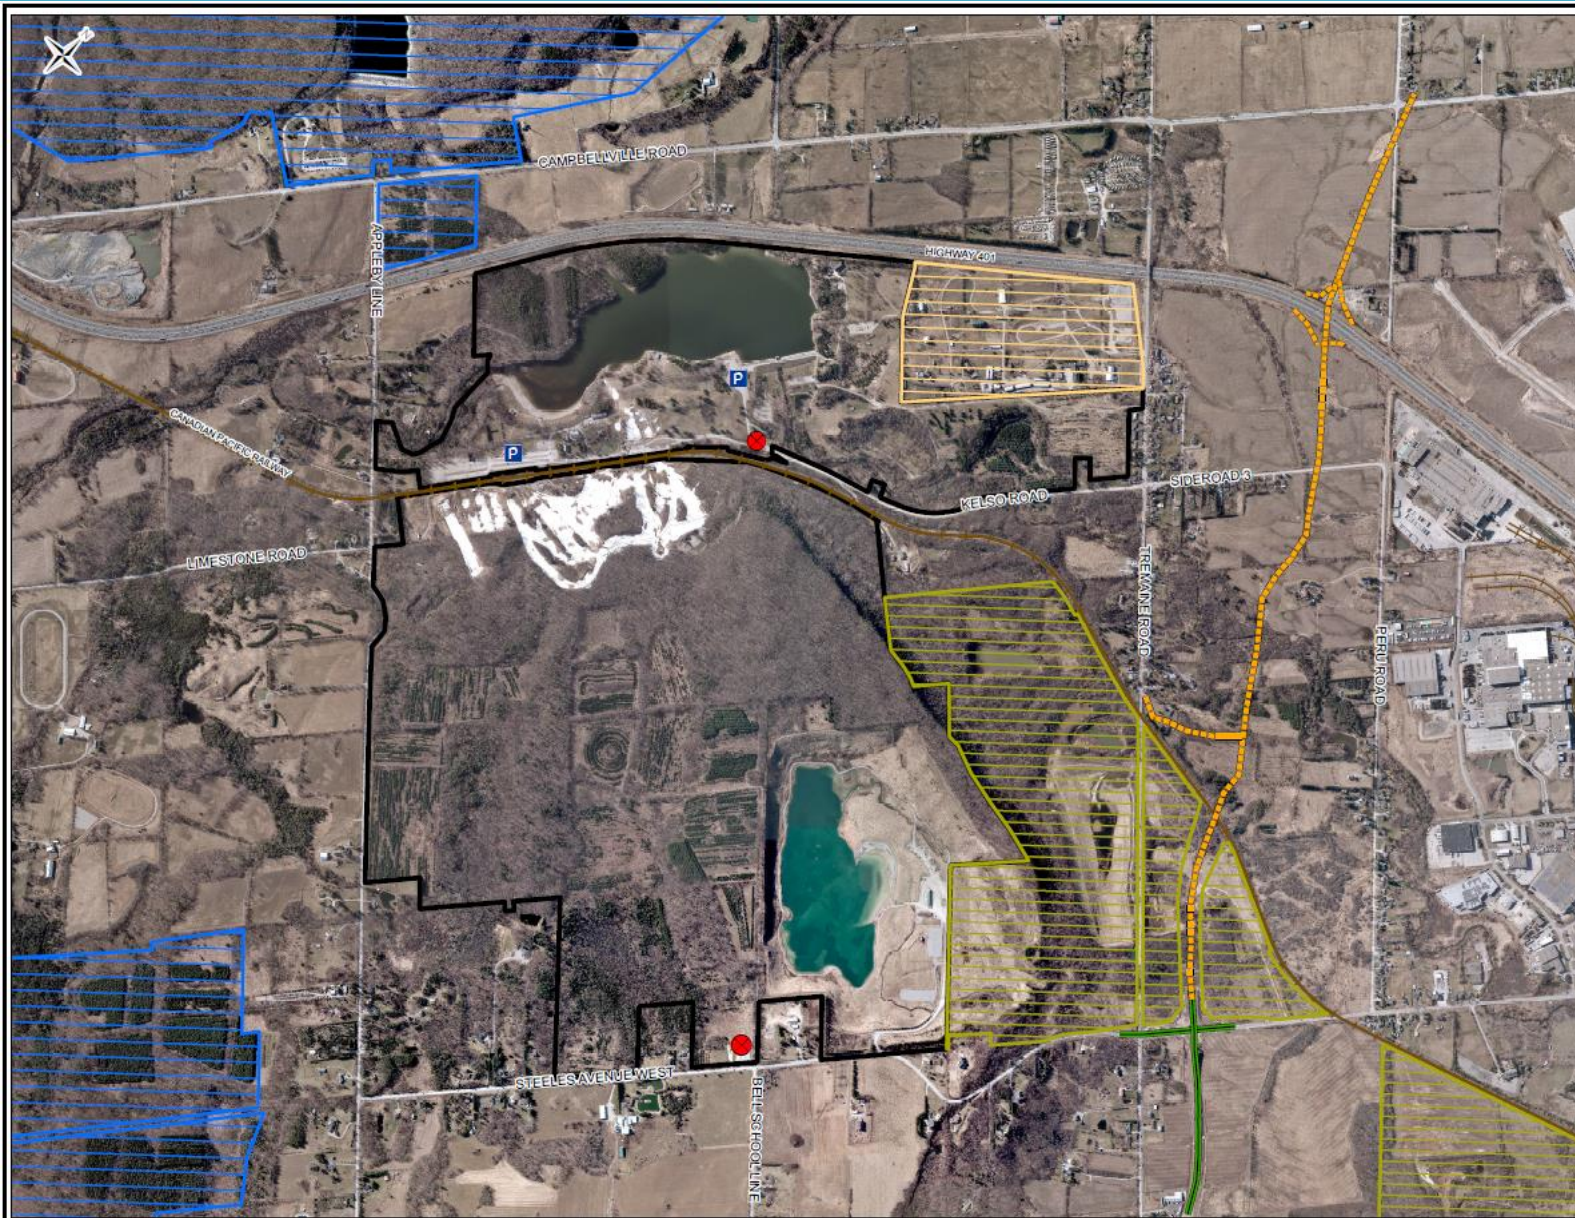
**Kelso Conservation Area
Figure 1**

- Kelso CA Boundary
- Conservation Halton Lands
- Town Of Milton Lands
- Country Heritage Agricultural Society Lands
- Parking
- Gatehouse
- Railway
- Remaine Road Alignment**
- Completed Work
- Planned Alignment & Interchange

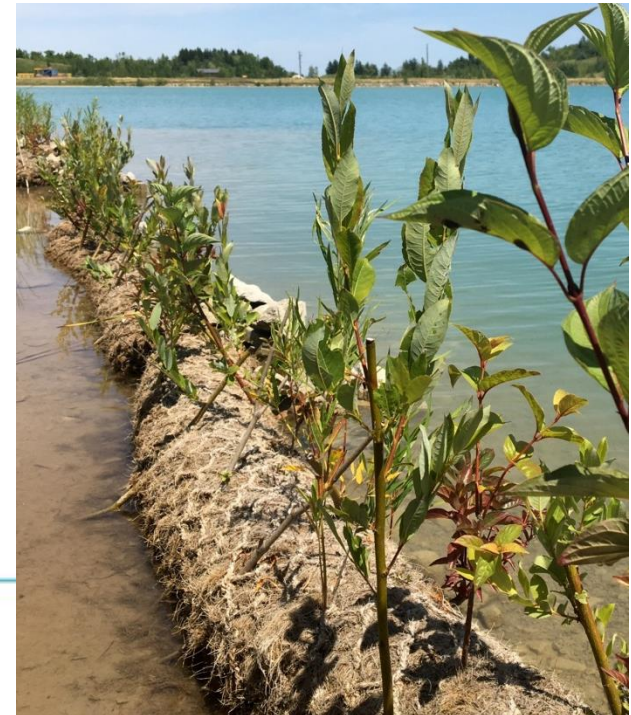
Marsh Planting

- Funded by the Federal Department of Fisheries and Oceans
 - *Recreational Fisheries Conservation Partnership Program*
- 4,000 m³ of new spawning shoals constructed
- 7 large fish habitat structures
- 6 floating wildlife logs
- Planted vegetation
 - 3500 wetland plants
 - 1000 trees & 1200 shrubs
 - 6 kilograms of tree nuts and wetland seeds

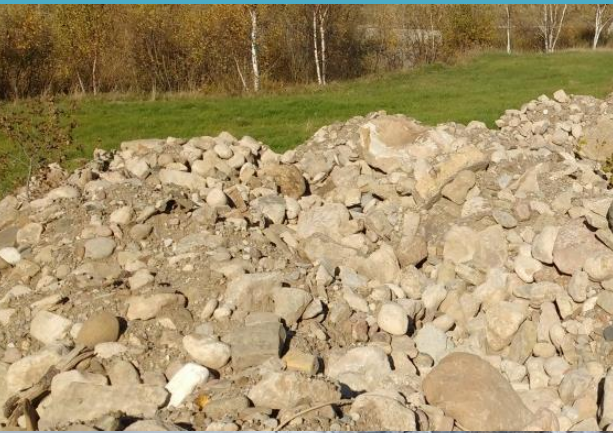
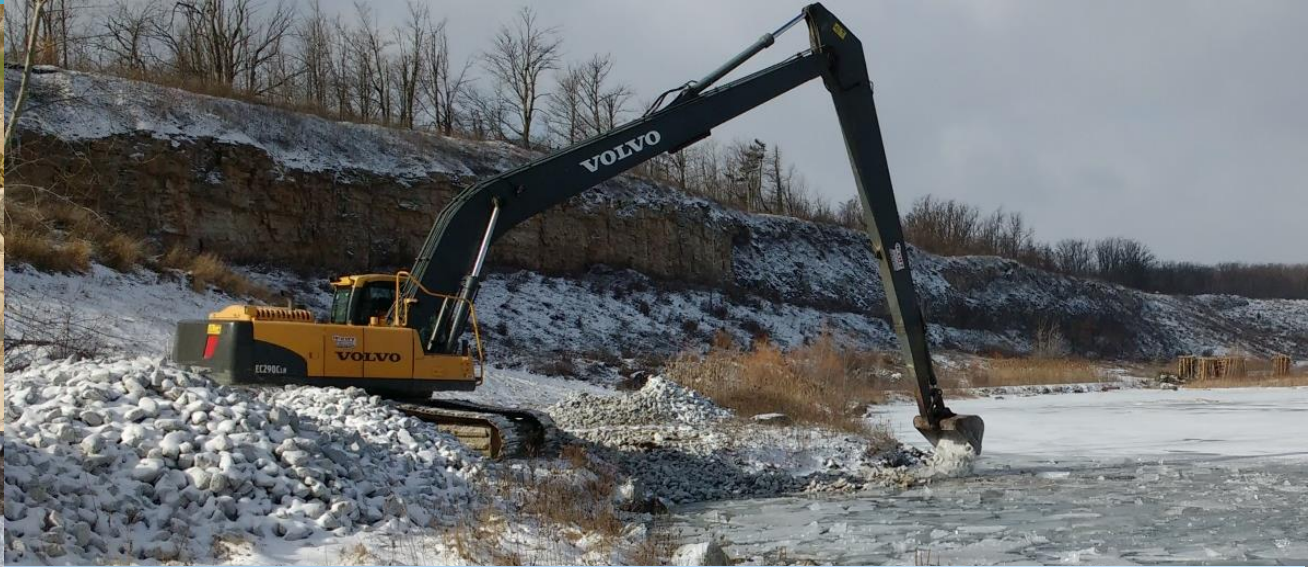
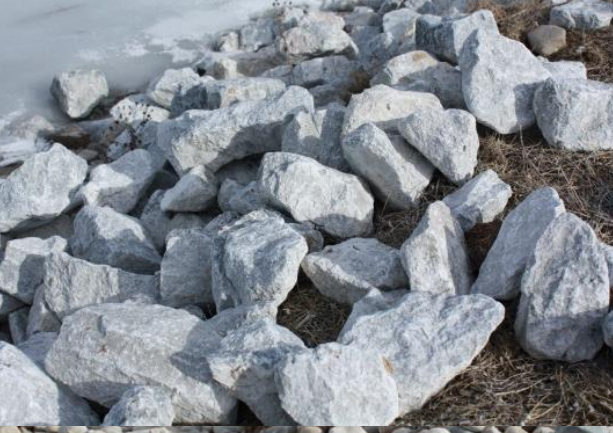
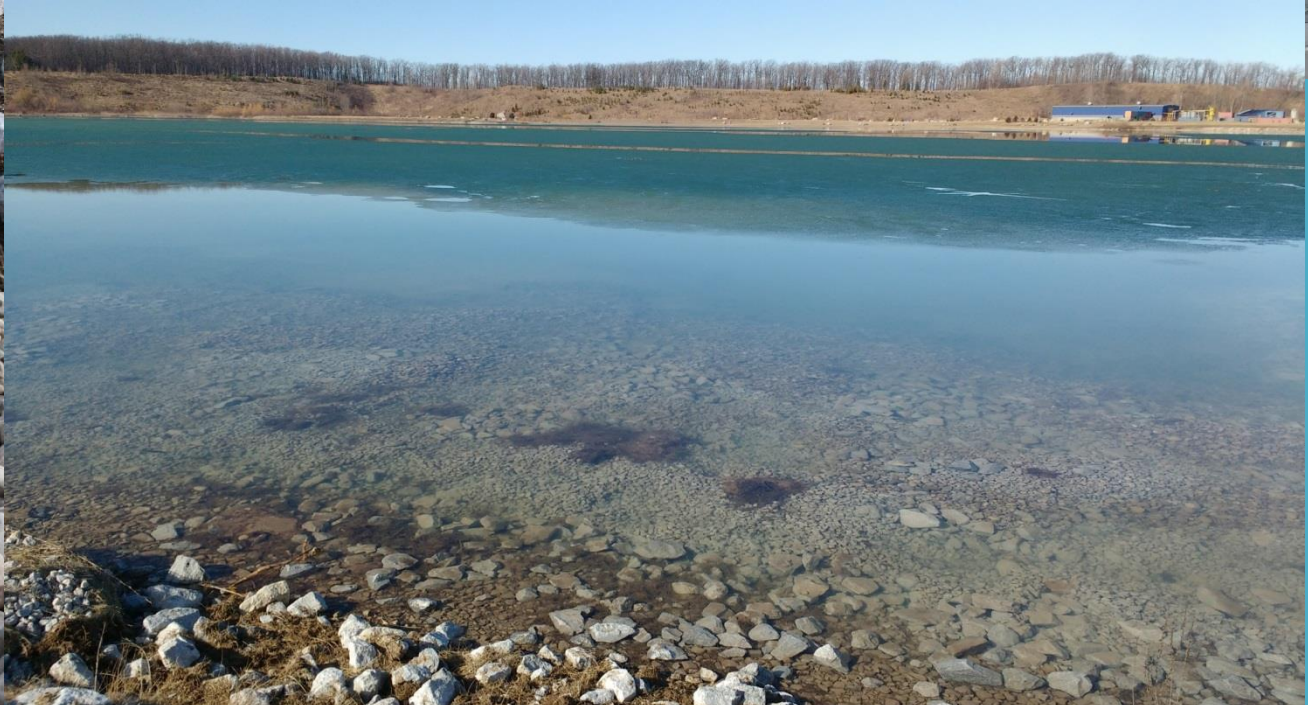
Kelso Conservation Area

DFO Recreational
Fisheries Conservation
Partnership Program

Restoration Features Shoal Creation

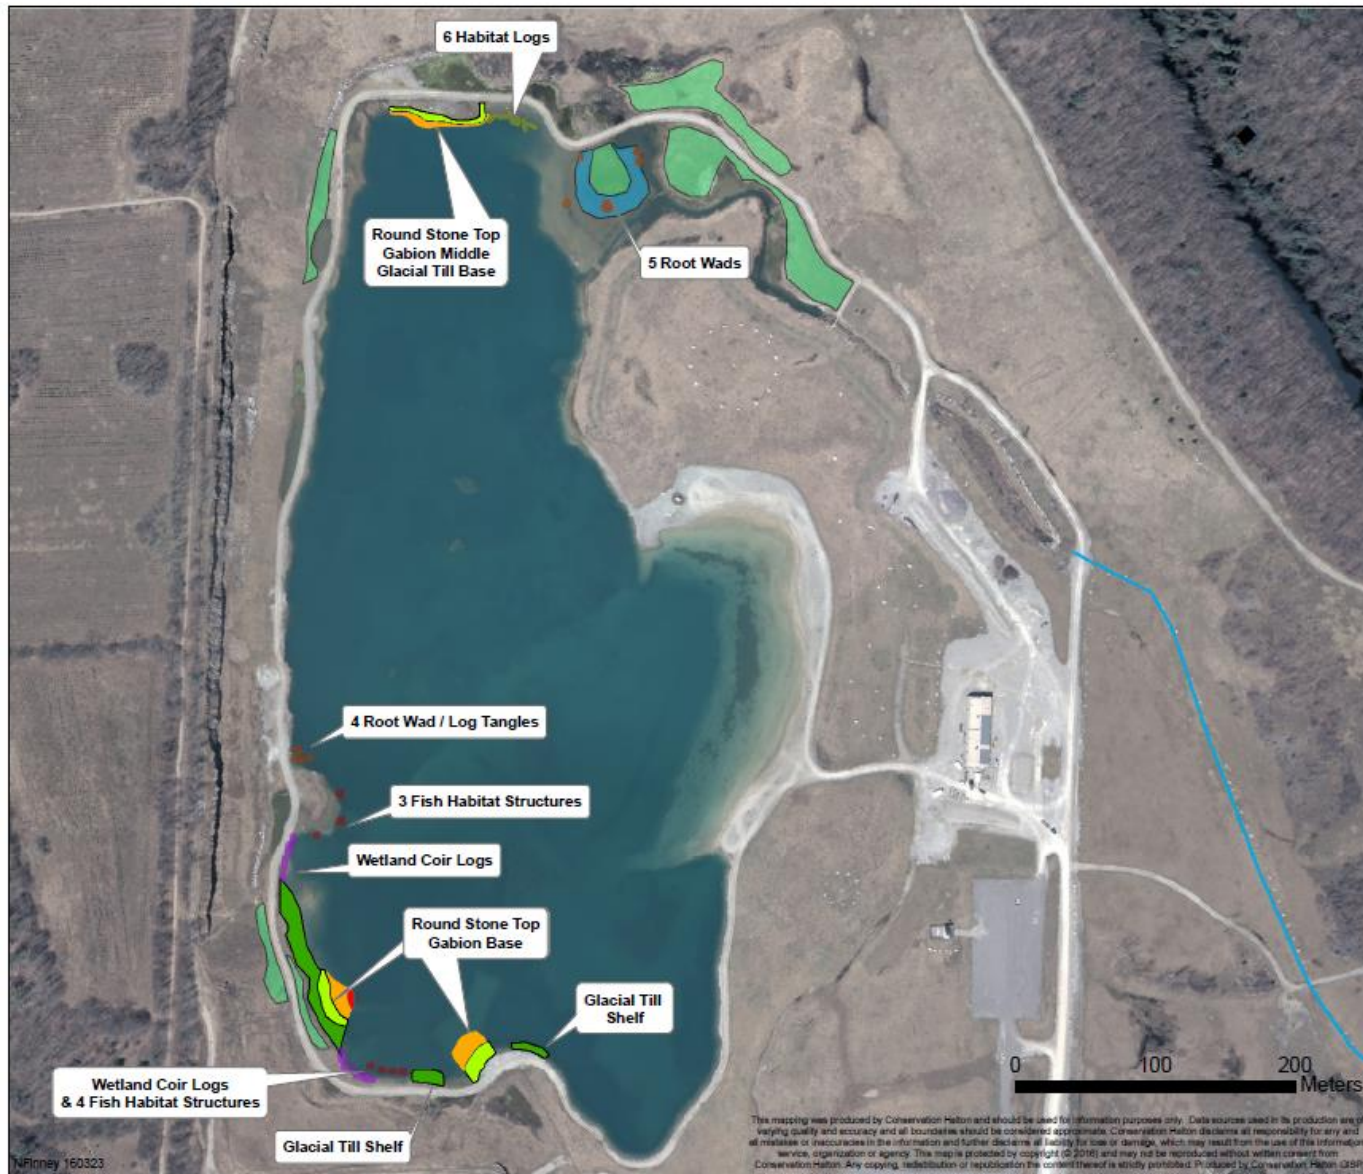
Riparian Forest

Emergent Wetland

Fish Habitat Structure

Wetland Coir Logs

Habitat Logs

Root Wads
